JUPITER™

Terminal State Code Definitions User Guide

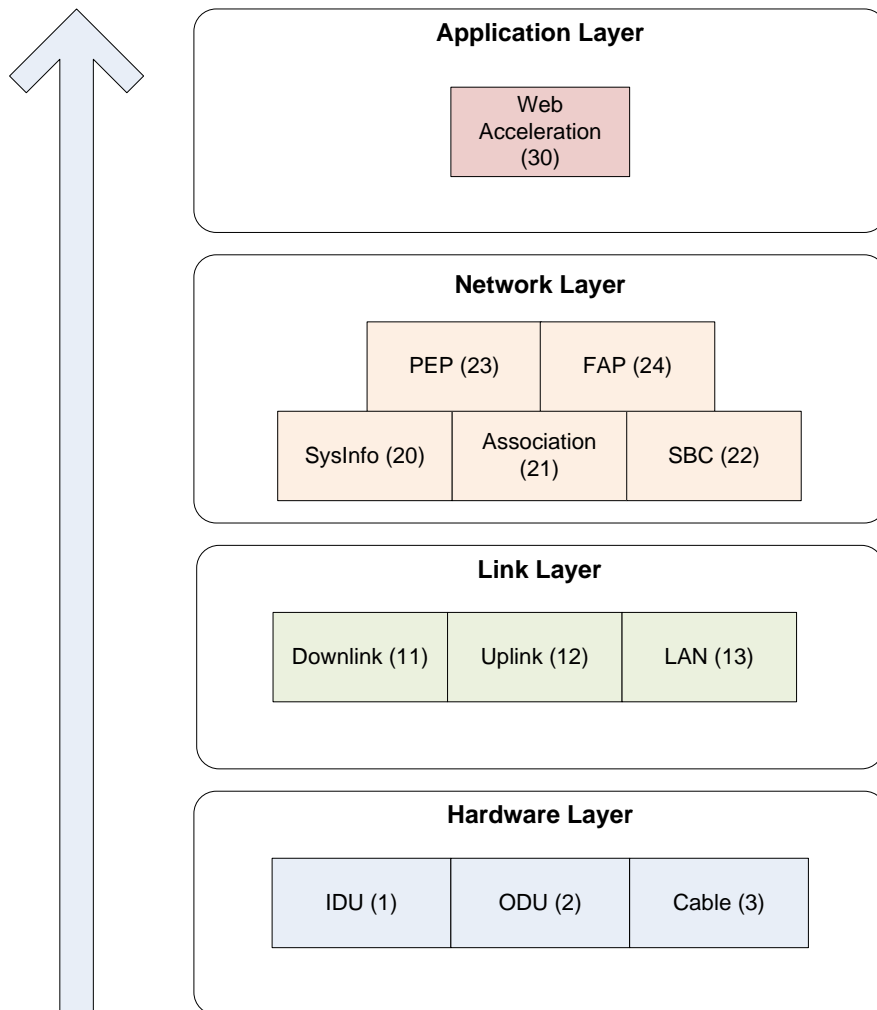
Each Component/Process, as shown in the figure below, maintains its own state code, independent of the other processes running in the terminal.

In addition to each Component/Process state code, the terminal maintains a *System State Code* that indicates the overall state code for the terminal. Typically this is the *lowest* process state code as the system state code works as a layered model (similar to OSI Network Model).

For example – if the Uplink has a problem, then this will also cause problems in Association, PEP, and Web Acceleration. In this case the Uplink problem is the root cause/problem that is affecting Association, PEP, and Web Acceleration. Therefore in this example, the System State Code would be reported as the corresponding Uplink state code.
